Title:	Sustainable amphibian protection through the use of natural processes
Contest: (Research/Community)	community stream project
Quarry name:	Penig/Elsdorf

Heidelberger Sand und Kies GmbH Am Siegelberg 1 99887 Georntal OT Gosptieroda		
Naturschutzverband Sachsen e.V. Gahlenzer Straße 2 09569 Oederan		
Quarry Life Award 2021 Kiessandtagebau Penig/Eisdorf Biotopbaumaßnahmen Kreuzkröte		
M 1 : 2.000	Plan 1	04.11.2021

Quarry Life Award 2021
 Kiessandtagebau Penig/Elsdorf
 Absteckung Biotopbaumaßnahmen

Fotodokumentation zum Abschlussbericht

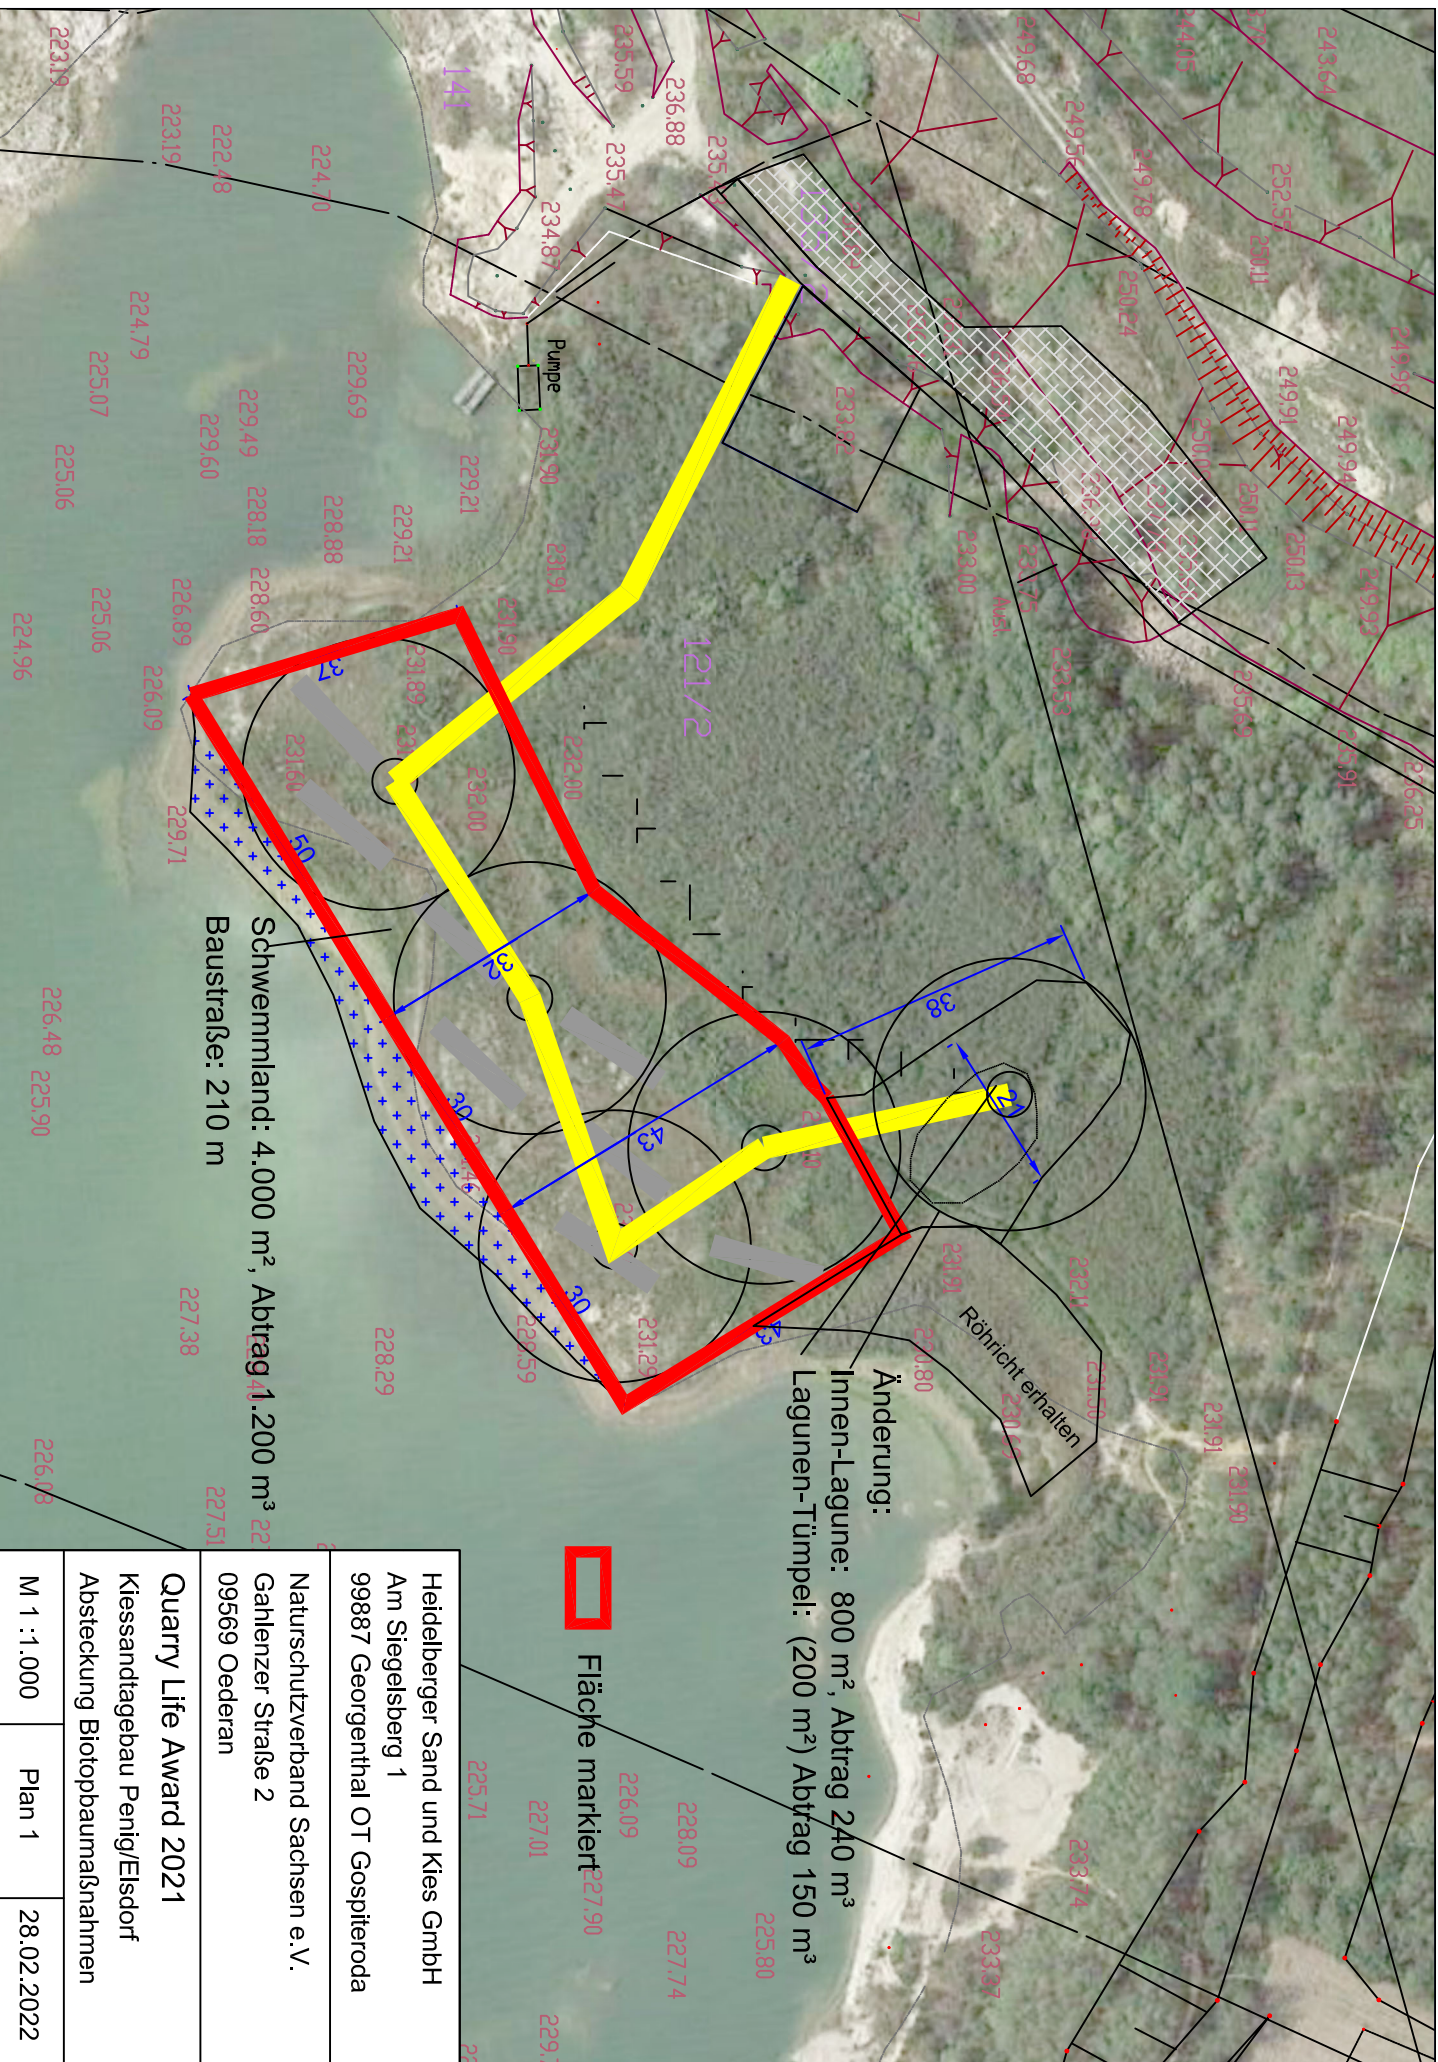
M 1 :1.000 Plan 1 28.02.2022

Änderung:
 Innen-Lagune: 800 m², Abtrag 240 m³
 Lagunen-Tümpel: (200 m²) Abtrag 150 m³

Schwemmland: 4.000 m², Abtrag 1.200 m³
 Baustraße: 210 m

Fläche markiert

(Annex 2 – Amended Plan of Measures from 28/02/2022) no longer included the lagoon dam, but an additional pond on the alluvial fan, which we dubbed the “inner lagoon” in analogy to the original plan. This pond with permanent waterlogging at the reed edge should also be designed as a fish-free amphibian spawning ground and is particularly suitable for tree frogs and water frogs.

Overall, the excavation work should remain within a 4,000 m² area of the alluvial fan. This work area was to be demarcated on-site and would therefore represent the binding local range of construction measures. Specific sub-measures for this area were vegetation removal (herbaceous vegetation and trees), extensive soil removal up to a depth of 0.3 m, the creation of 8 gully-like ponds up to 1 m deep and the creation of another pond on the reed edge of at least 1 m deep. The gully shape of the ponds is analogous to the excavator tracks in excavation sites, whose characteristics are determined by the engineering, and therefore tackles the resulting soil damage. Another reason for choosing this pond shape is the weather-related erosion processes that take place in excavation sites. Bank edges created in small-scale work processes would quickly disappear again, which is why they were not used.

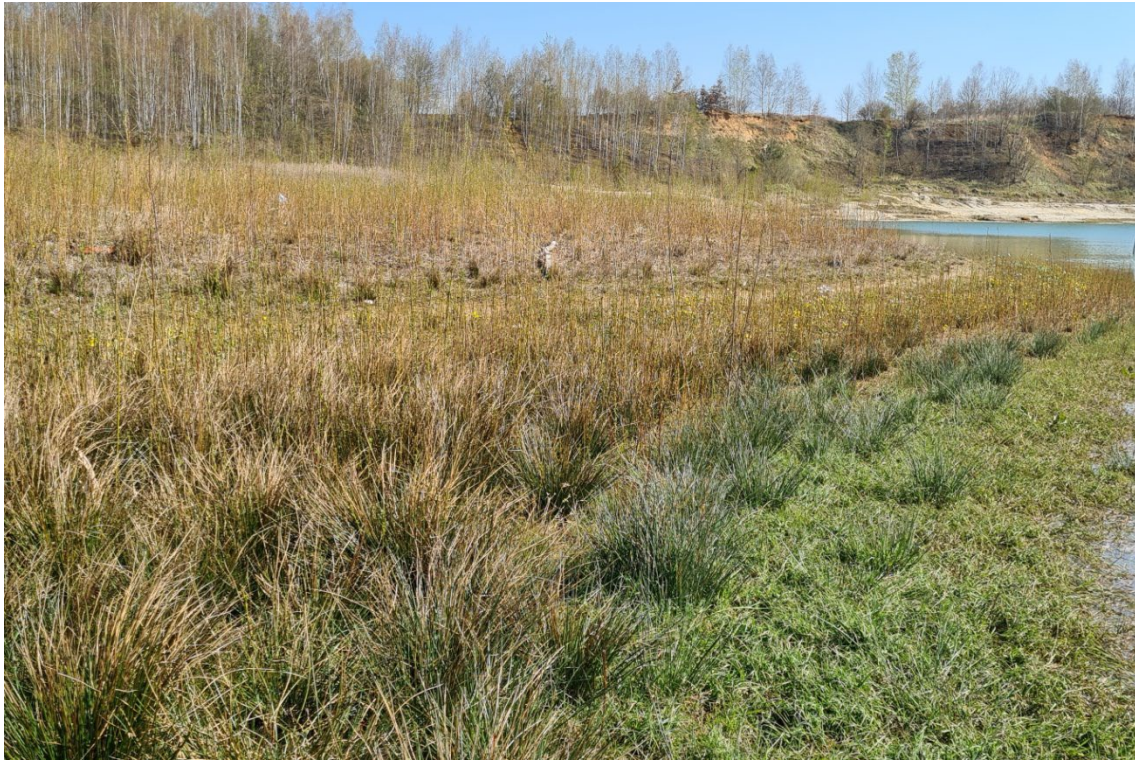
Foto 1: Schwemmfächer vor Beginn des Projektes im April 2021

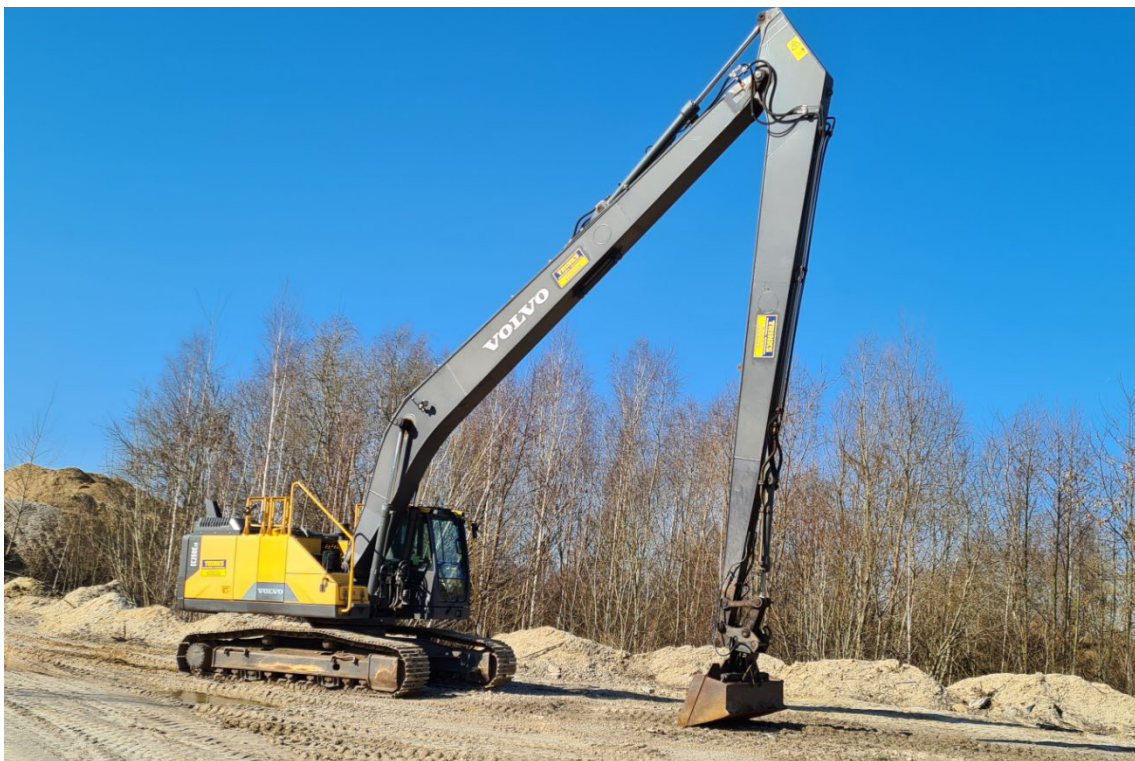
Foto 2: Langarmbagger, der letztlich nicht zum Einsatz kam

- Use of the long-arm excavator will be discontinued.

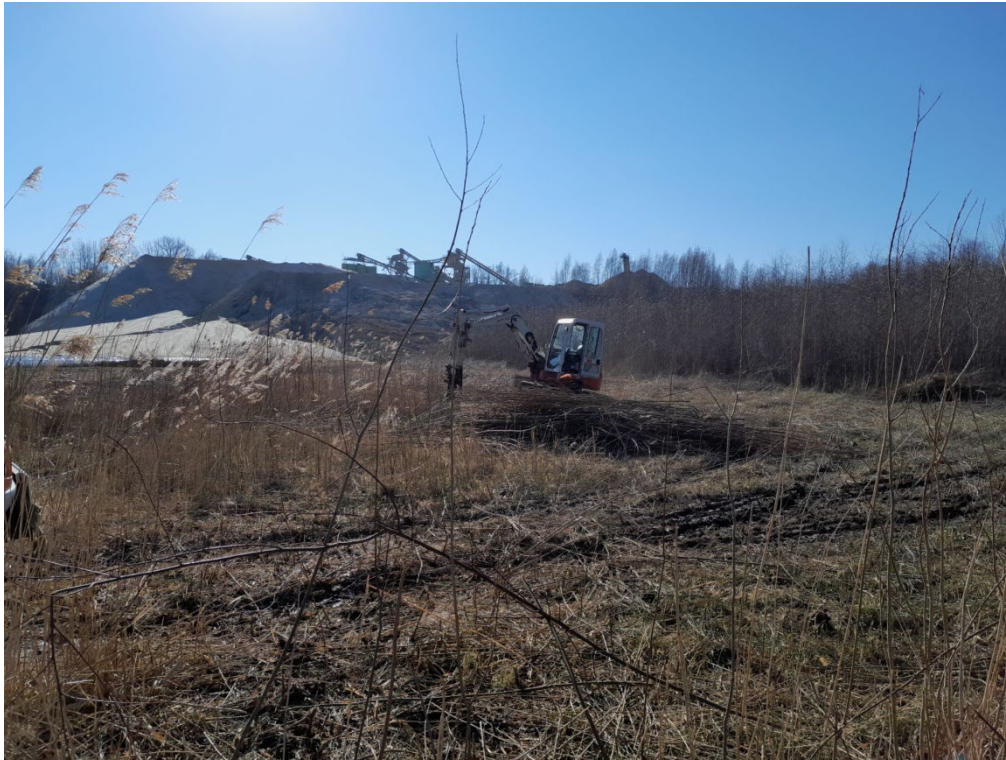
Foto 3: Arbeiten zur Beseitigung der Vegetation

In the last week of February, the project area was measured and staked out. The Berthold construction company then removed the vegetation on the alluvial fan over an area of 4,000 m² using both manpower and machinery. The water-saturated bottom of the alluvial fan presented a major challenge when using machinery. The mulcher got stuck several times and sank in the alluvial sand, so in the end, work had to be done by hand. The plan to mulch the area of the future pond (“inner lagoon”) also had to be abandoned because the area was far too wet.

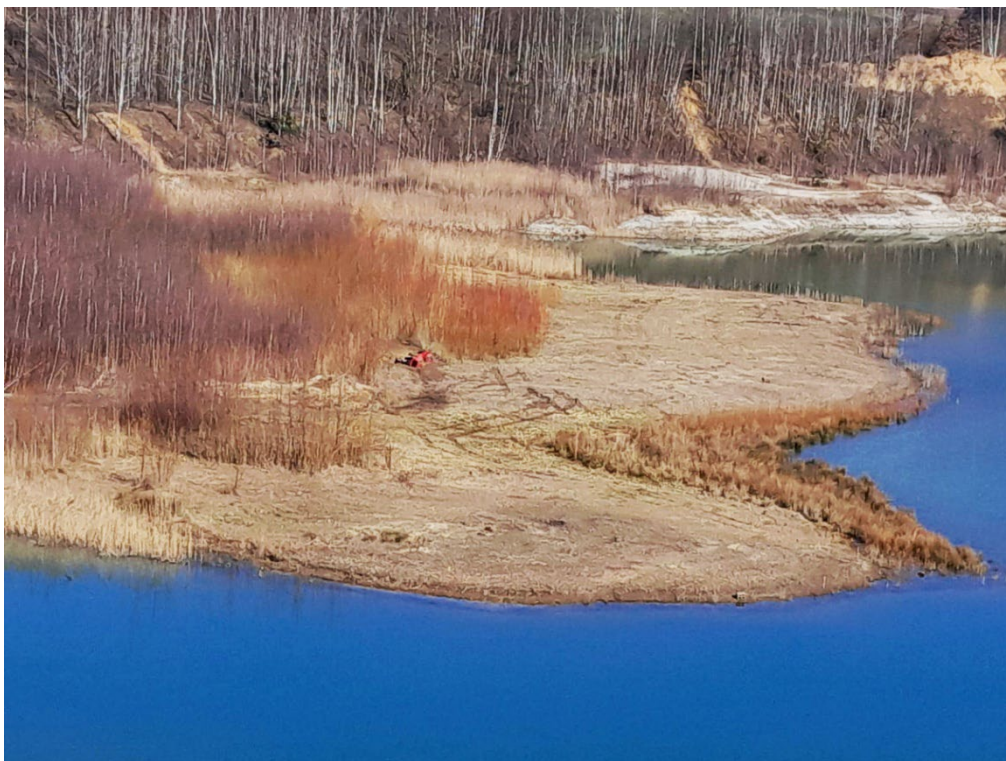
Foto 4: Schwemmfächer ohne Vegetation, März 2022

The woody mulch material (willow and birch up to 4 cm thick) was deposited in heaps at the edge of the alluvial fan as an additional biotope element. In March 2022, a 4,000 m² area of the alluvial fan was once again free of vegetation.

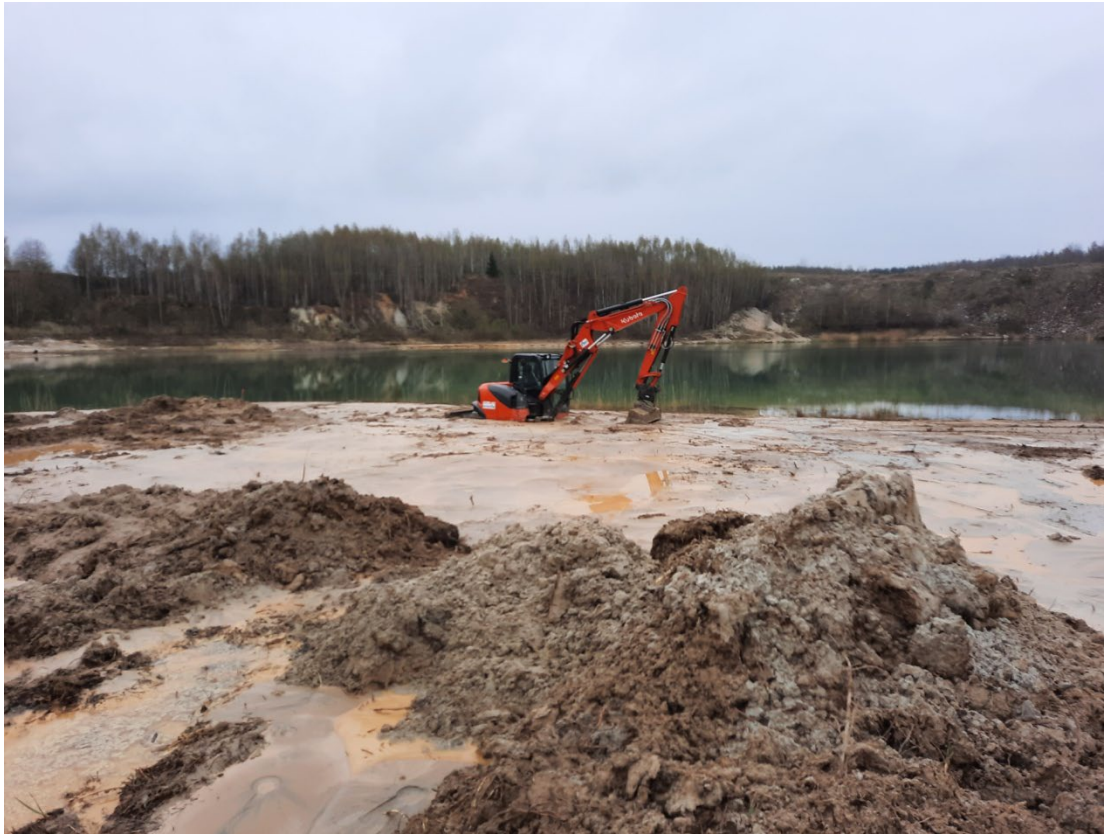
Foto 5: beim flächigen Bodenabtrag eingesunkener Bagger, April 2022

Right on the first day of operation, the excavator sank into the wet ground despite the use of excavator mats. Mr. Berthold from the construction company therefore suggested a new technology. This required piling up the excavated soil material first to form a dam, on which the excavator can then drive. From this earth dam, the excavator can carry out further soil removal or gully excavation on both sides. The earthen dam is then removed again upon leaving. A test run was promising. However, this technology meant that more ground had to be moved.

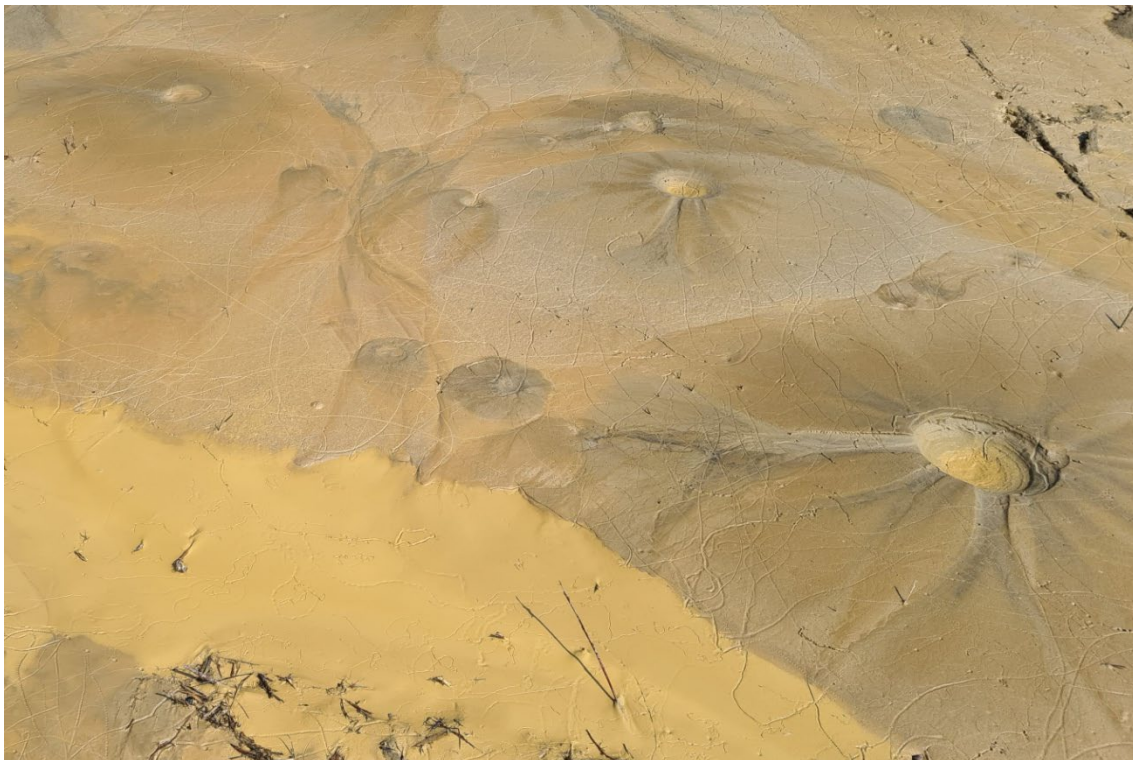
Foto 6: Wasseraustritte auf dem abgeschobenen Flächen des Schwemmfächers

The mowing work showed heavy construction equipment can only be used to a limited extent for the pending earthworks – despite the use of excavator mats. The ground, now free of vegetation, was however so saturated with water that it began to flow under greater pressure or vibration and every construction machine literally sank. Water discharged locally in many places. As part of the joint construction meetings with the gravel pit operator, construction company and ourselves, a technology was sought to implement the project despite the adverse conditions.

- This requires knowledge of the groundwater and surface water dynamics in the mining area.
- The soil composition of alluvial surfaces is inhomogeneous and unstable. They are saturated with water, even if they appear dry on the surface. The water is discharged by pressure and vibration and starts to flow.

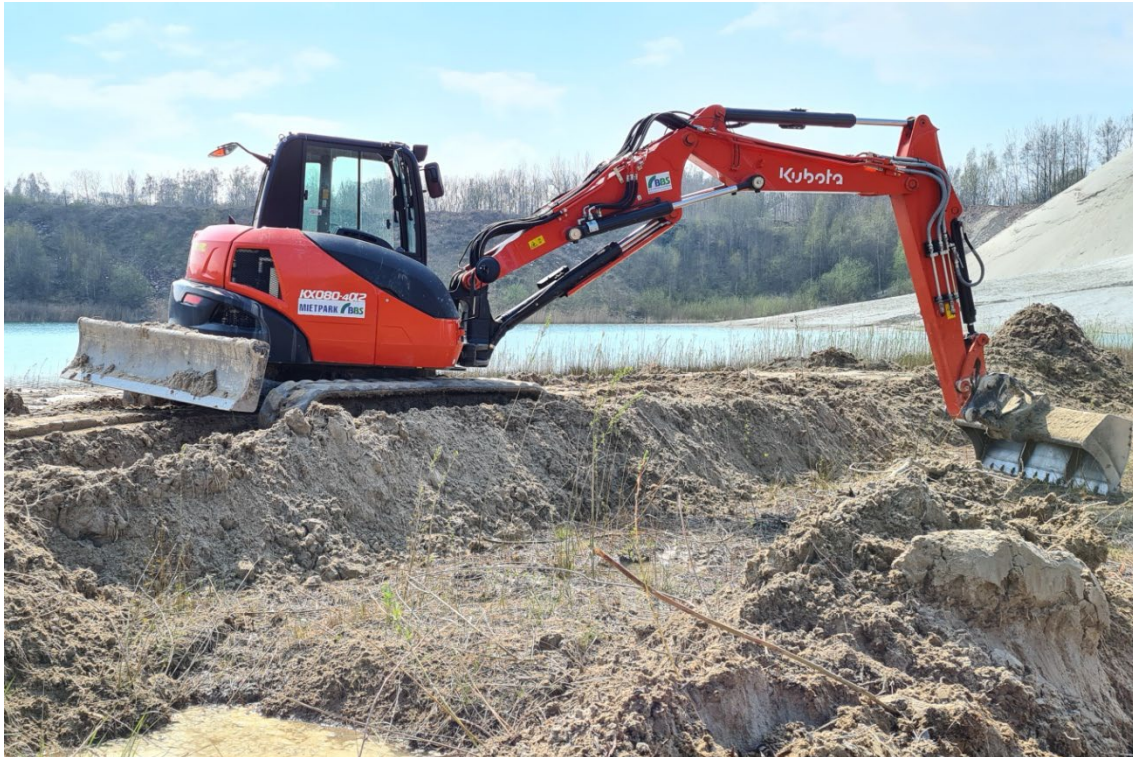
Foto 7: neue Technologie – Erddamm als Baggerstraße

- Earthworks on alluvial land require an adapted technology. The installation of temporary earth dams as a form of construction road represents one option to carry out earthworks even on water-saturated soil.

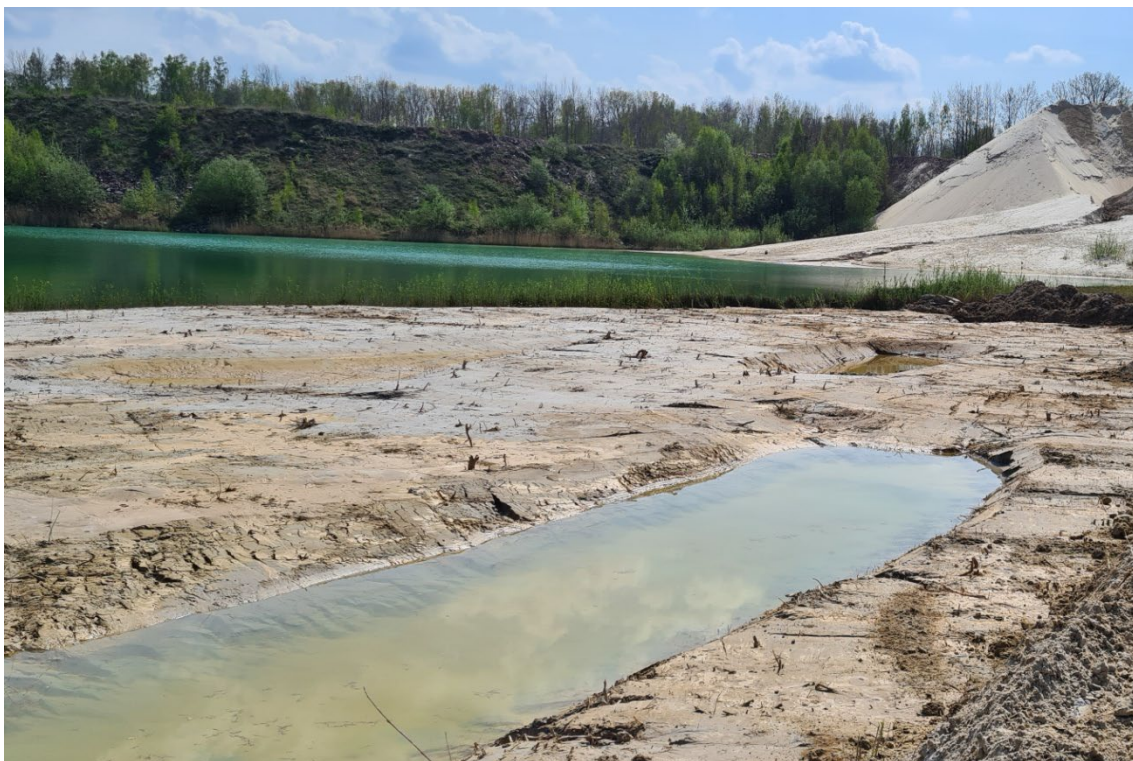
Foto 8: eine der 8 Rinnen

- Areal removal of trees, bushes and herbaceous vegetation over 4,000 m²
- Areal soil removal up to a depth of 0.30 m over 4,000 m²
- Installation of deadwood structures and ground walls on the landside edge of the area being covered
- Installation of 8 gully-like ponds with a length of approx. 10 m and a depth of up to 1 m
- Installation of a pond at reed edge with a depth of up to 1 m
- Final tilling of the entire ground over an area of 4,000 m².

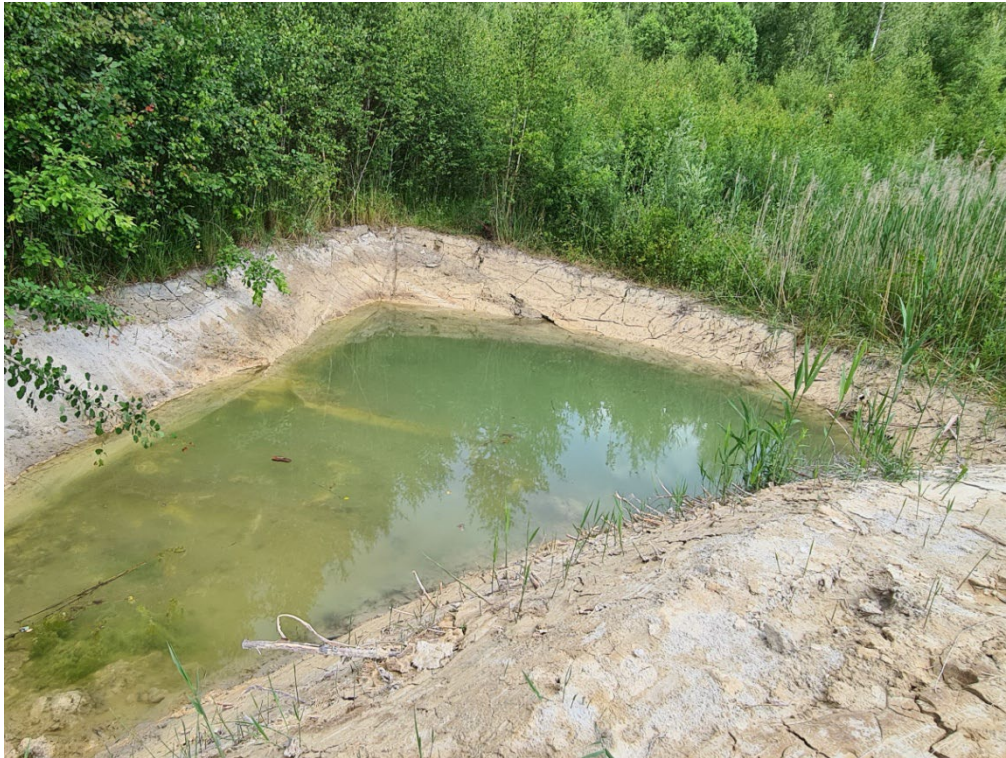
Foto 9: Tümpel am Schilfrand

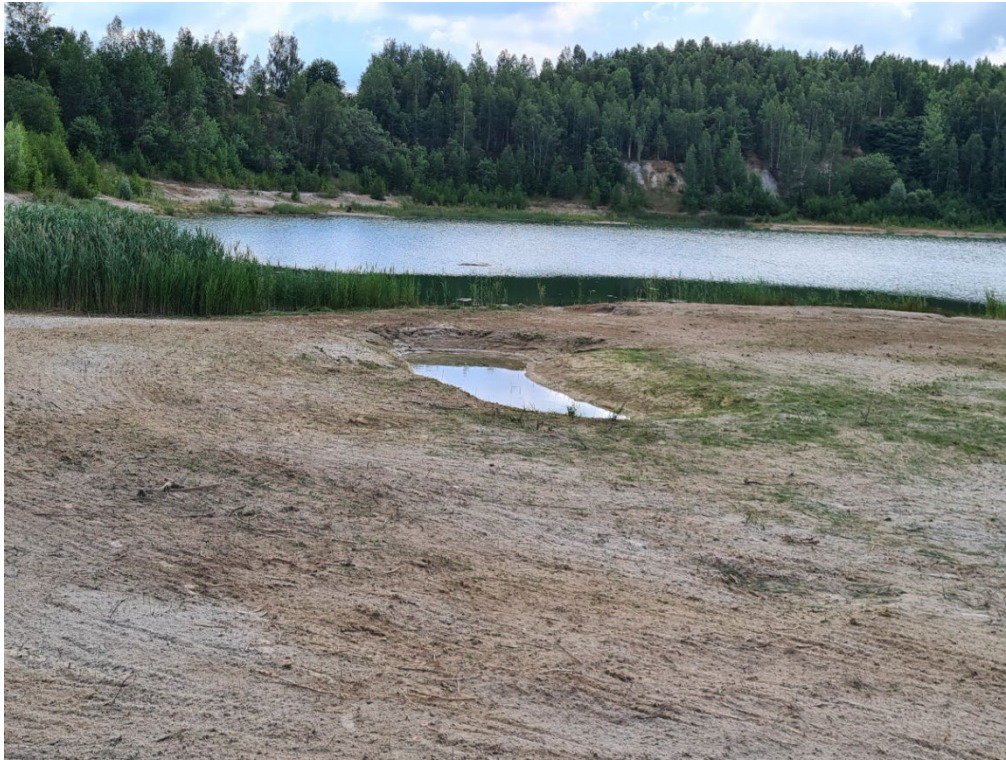
Foto 11: Fläche nach Oberboden-Fräsen

- The efficacy of tilling the surface to remove vegetation has not yet been confirmed. It is possible this only crushes rhizomes allowing them to sprout again in greater numbers.
- The development of the project area depends on the water level in the residual lake and therefore precipitation in the coming years. If an elevated lack of precipitation persists, the extensive soil excavation measures carried out will not suffice to maintain open structures in the long-term because they were not deep enough.
- Unfortunately, the area not only became more attractive as an animal habitat, but also as a leisure retreat for people. Seclusion can only be guaranteed if illegal entry and driving is prevented consistently.
- It can also be achieved without complex planning, but a lot of improvisational skill is required from those involved.

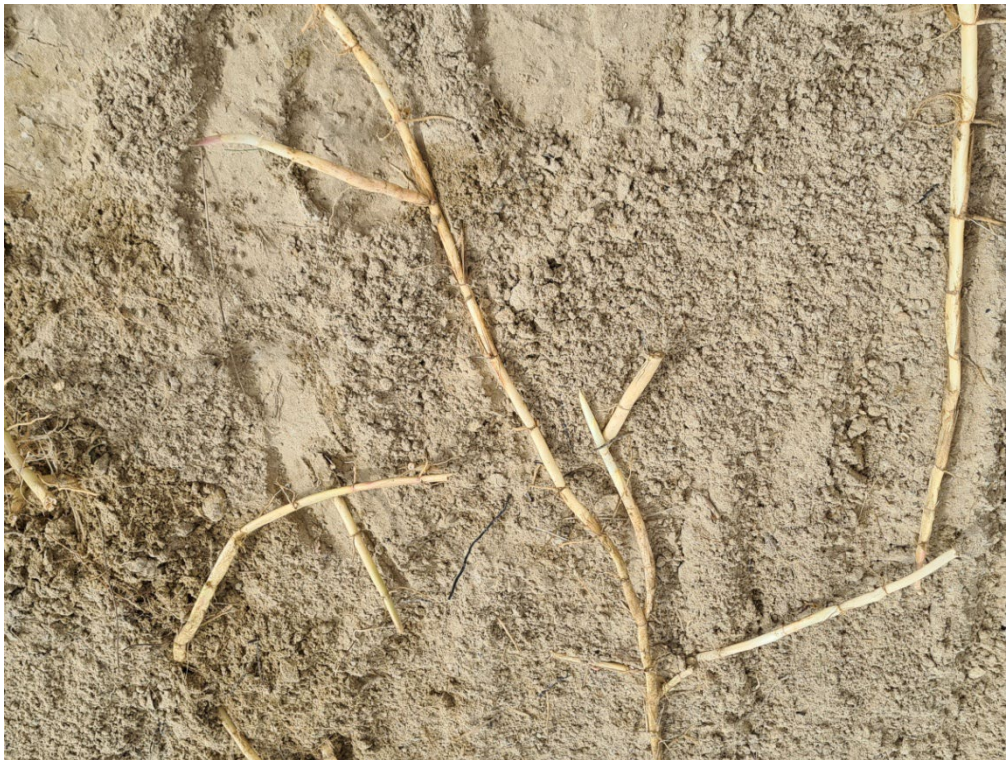
Foto 12: Rhizom des Rohrglanzgrases

- Areal soil excavation of < 0.3 m does not cover all roots, not even those of herbaceous vegetation. The rhizomes of canary grass and reed reach much deeper into the ground. If the area is to be kept clear for a long time, soil excavation of at least 0.50 m is necessary. Tree roots reach deeper and may need to be removed individually.

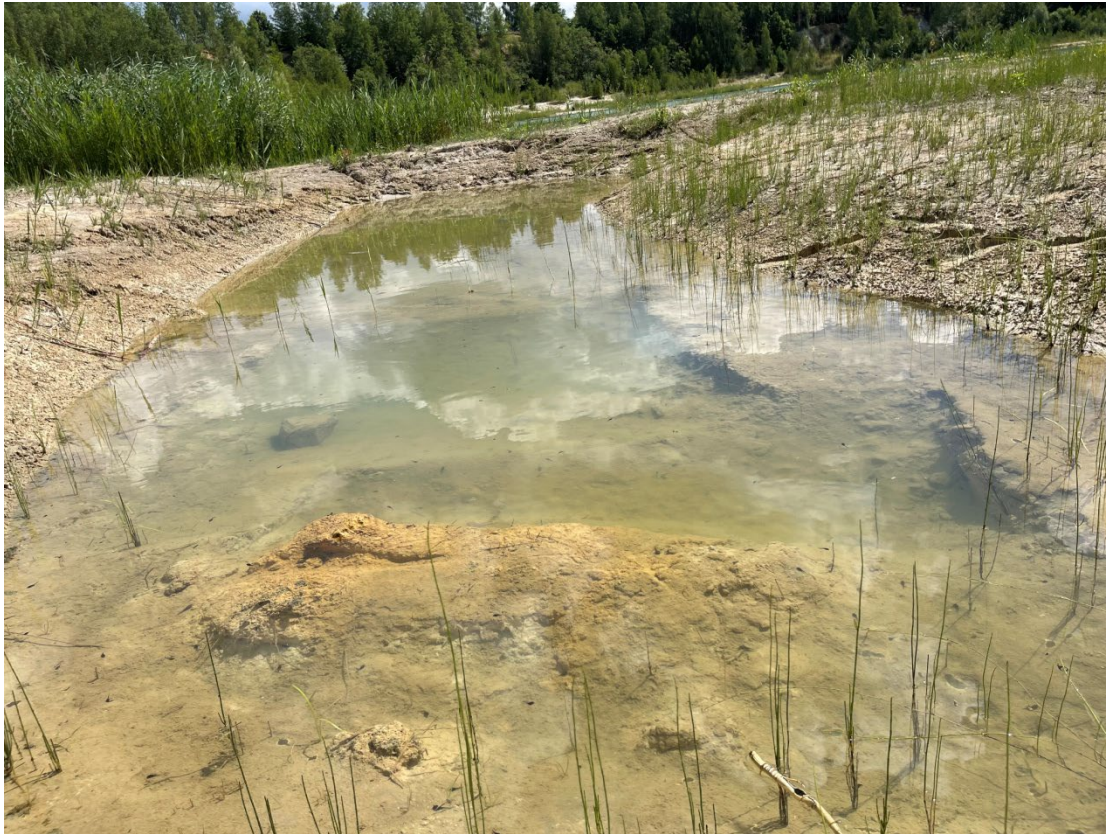
Foto 13: Kaulquappen in einer der Rinnen, Juli 2022

Photo 13: Tadpoles in one of the gullies, July 2022

Despite the drought that has persisted since May, there was water in most of the gullies, also in the pool at the edge of the reeds. Amphibian monitoring provided evidence of successful reproduction of the green toad in the gullies and in the pond. Furthermore, pond frogs were also found in the pond. The little ringed plover was observed regularly on the alluvial fan.

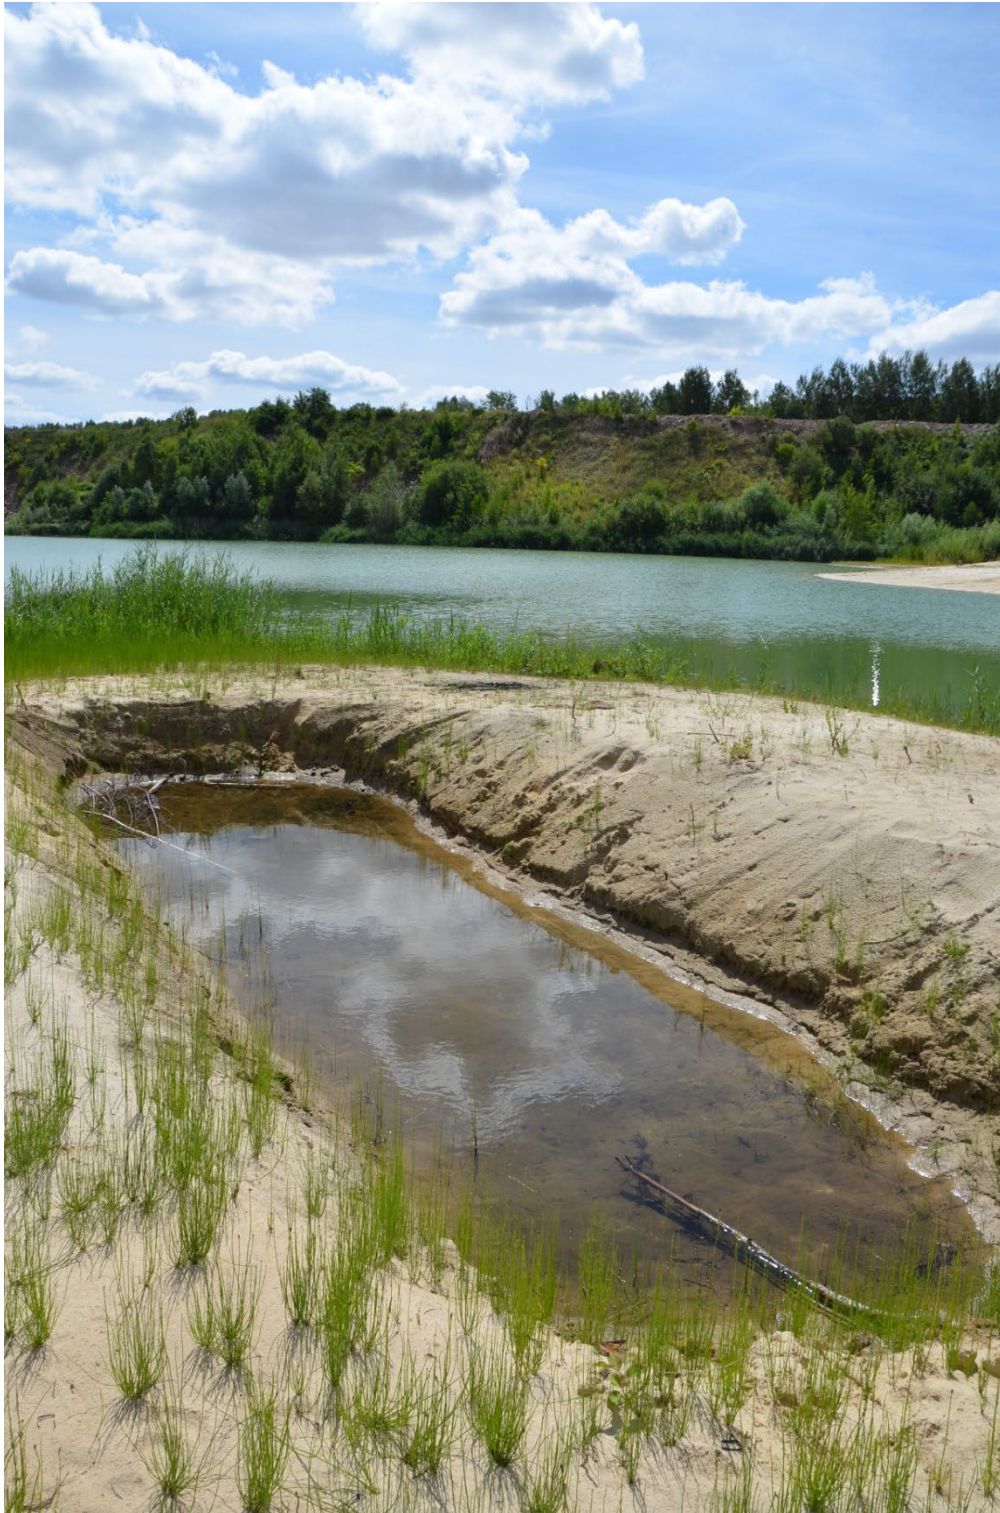
Foto 15: eine der Rinnen am 06.08.2022 nach langer Trockenheit
